# Kern River No. 1 Sediment Management Practices

February 2009

# Meeting Objectives

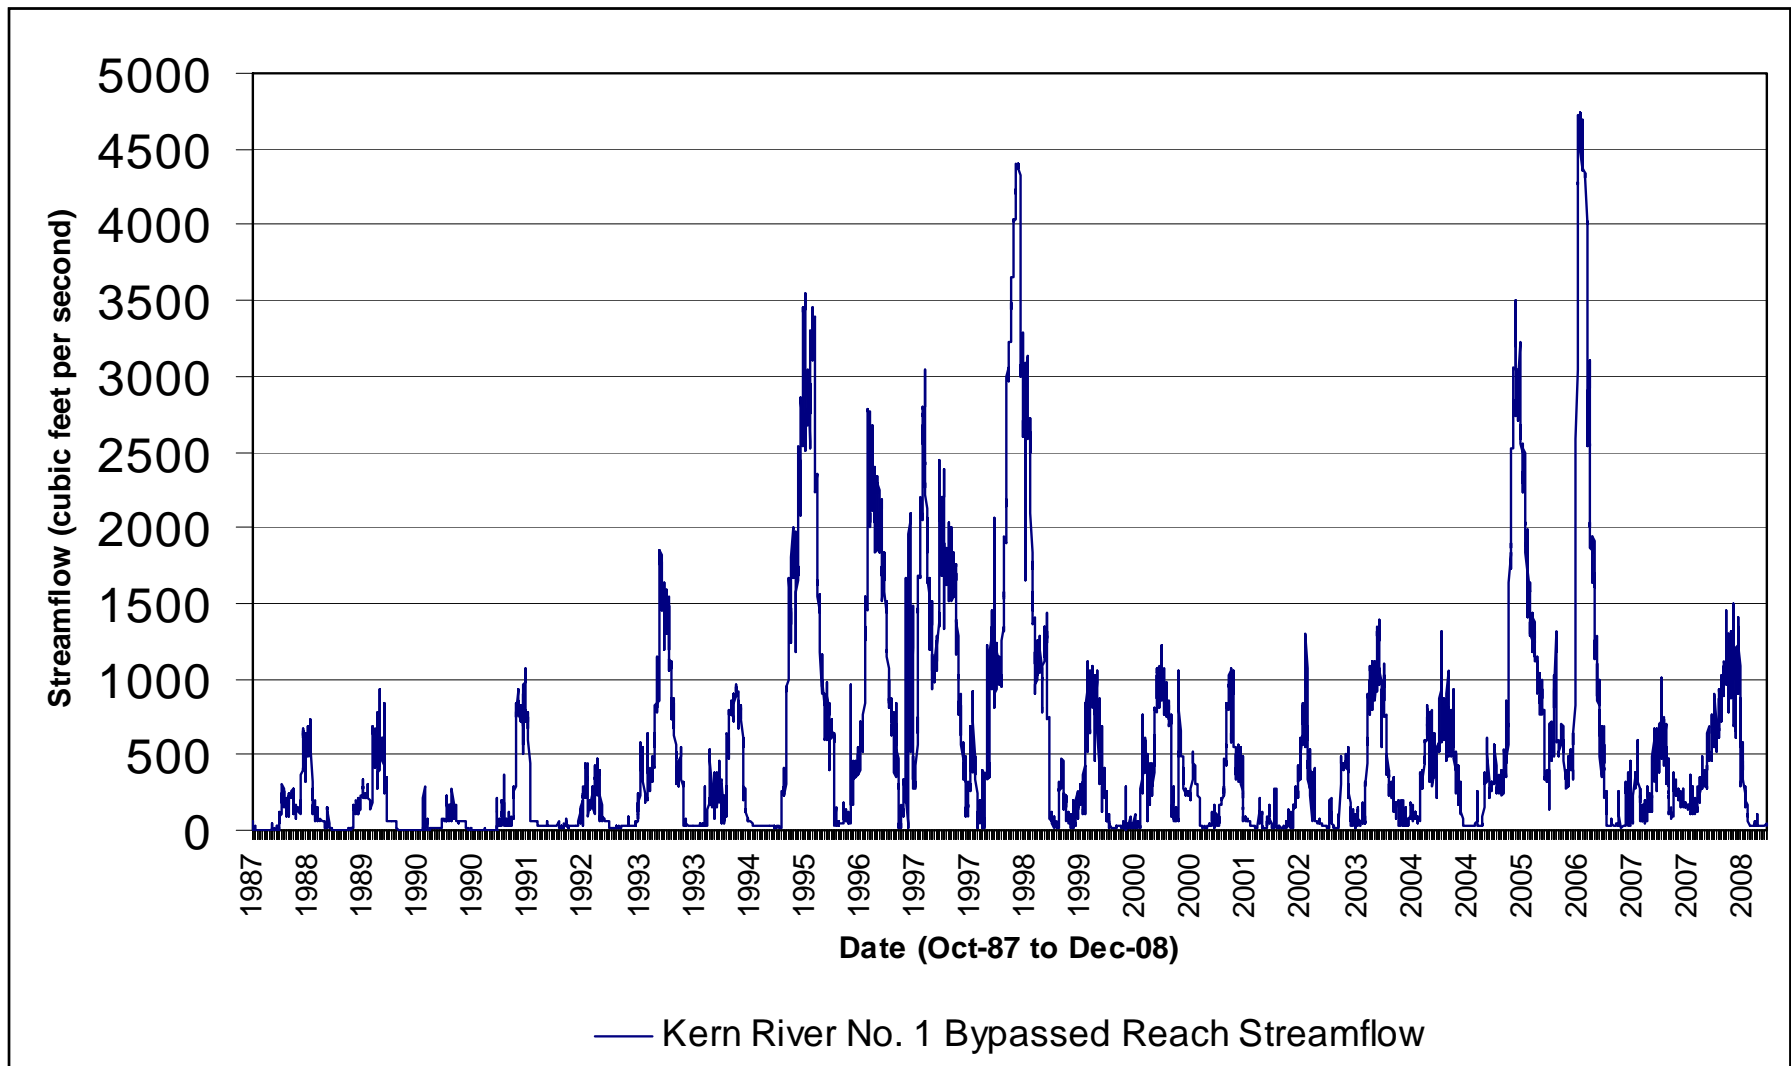
# KR1 Bypassed Reach Hydrograph (1988-2008)

- Fate of 2001 Sediment Release
  - 2005: Flow exceeded 1,000 cfs in bypassed reach from May 20 to October 15, peak of 3,500 cfs
  - 2006: Flow exceeded 1,000 cfs in bypassed reach from April 20 to August 10, peak of 4,740 cfs
  - Transport model predicted flows in 2005 would scour the deposit, confirmed by visual observations
  - 2006 releases provided further scour
  - Bypass reach channel morphology is in the unimpaired state
- 2007 Full Pond Drain (approx. 20,000 cubic yards)
  - No monitoring performed in 2008 (2007 WY) due to tunnel outages during the low flow season
  - 2009 Monitoring: Temporary sediment storage at Pool 1 (first prominent low gradient area; Richbar areas are next)

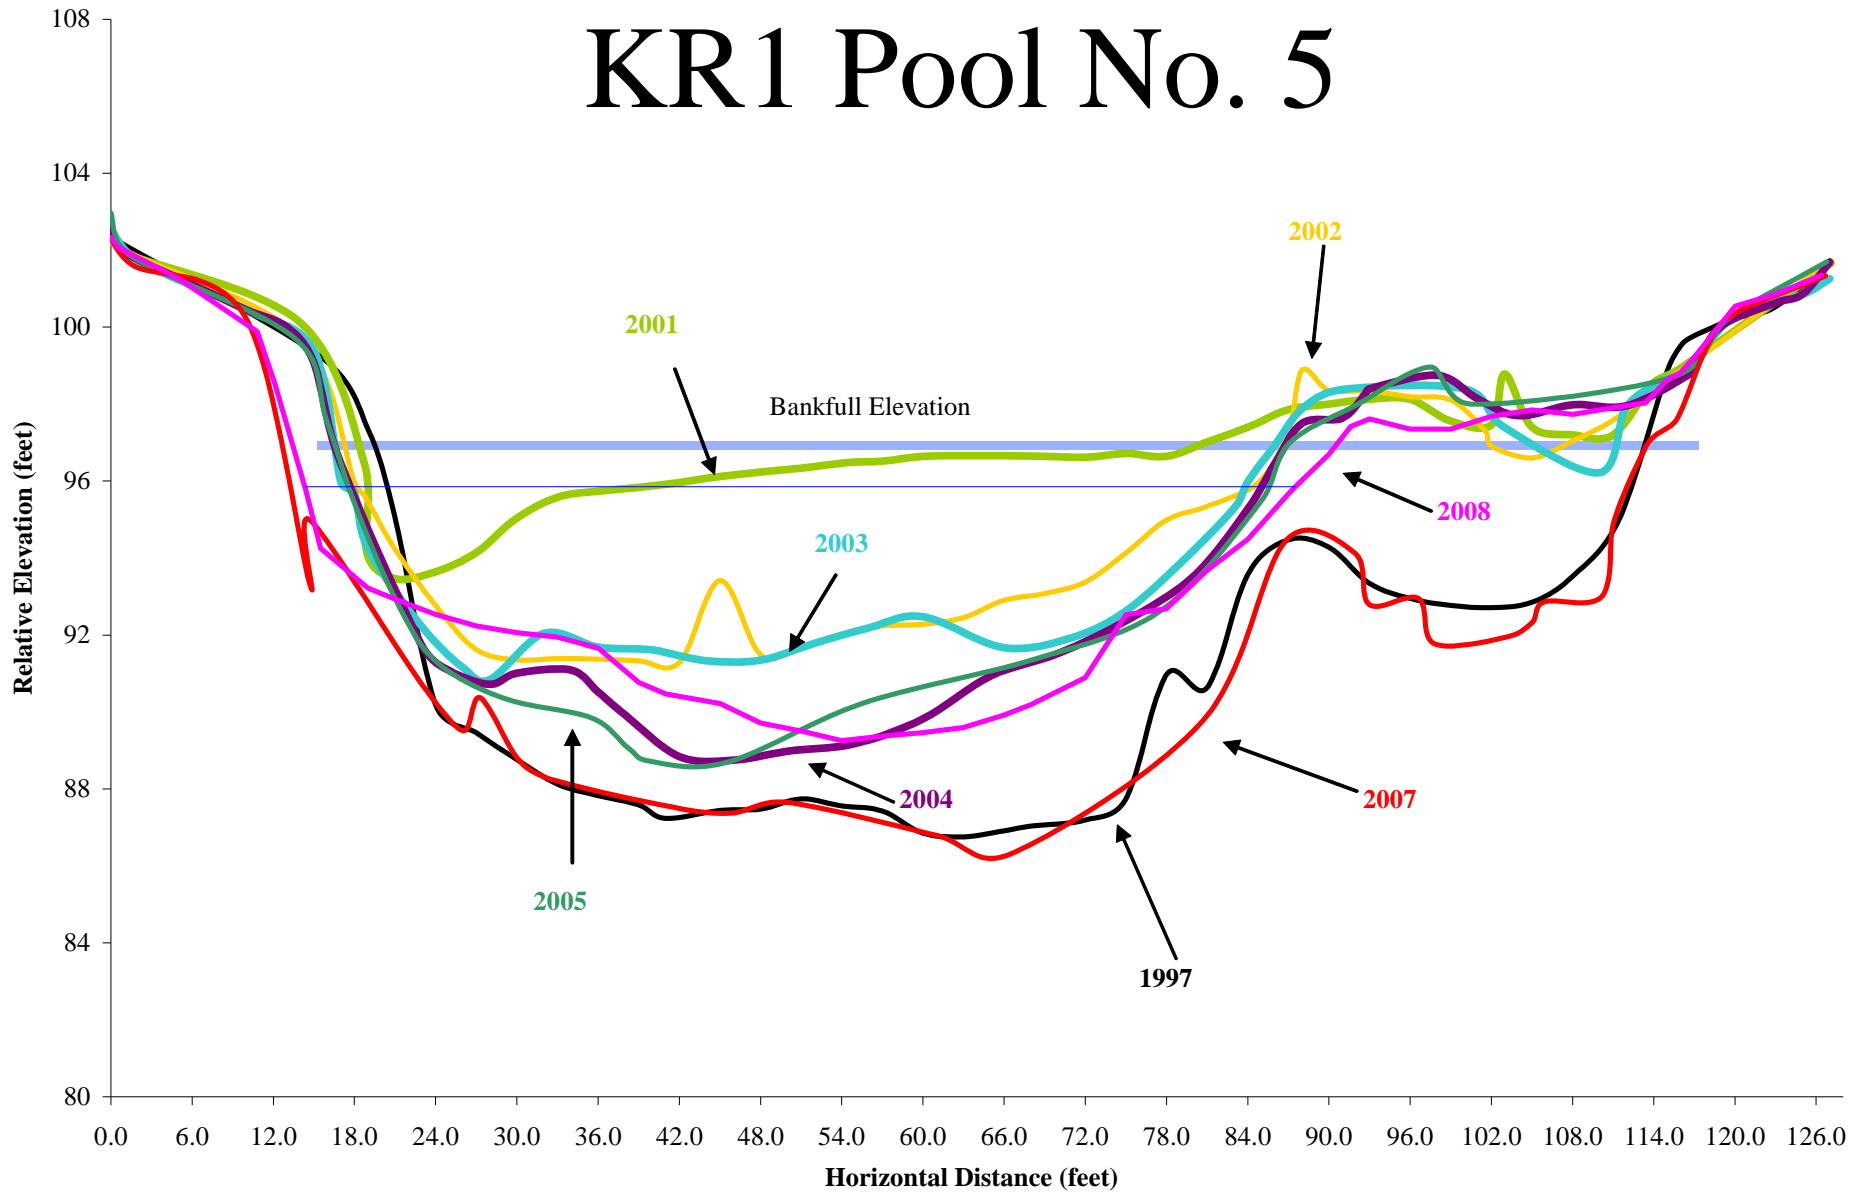
# KR1 Pool No. 5

- Minor sediment deposition measured at Pool 5
- Sediment deposition measured at Pool 1
- The remaining 6 pools remain relatively scoured throughout the KR1 bypassed reach
- The majority of the bypassed reach continues to operate within the unimpaired transport capacity measured in the late 1990's

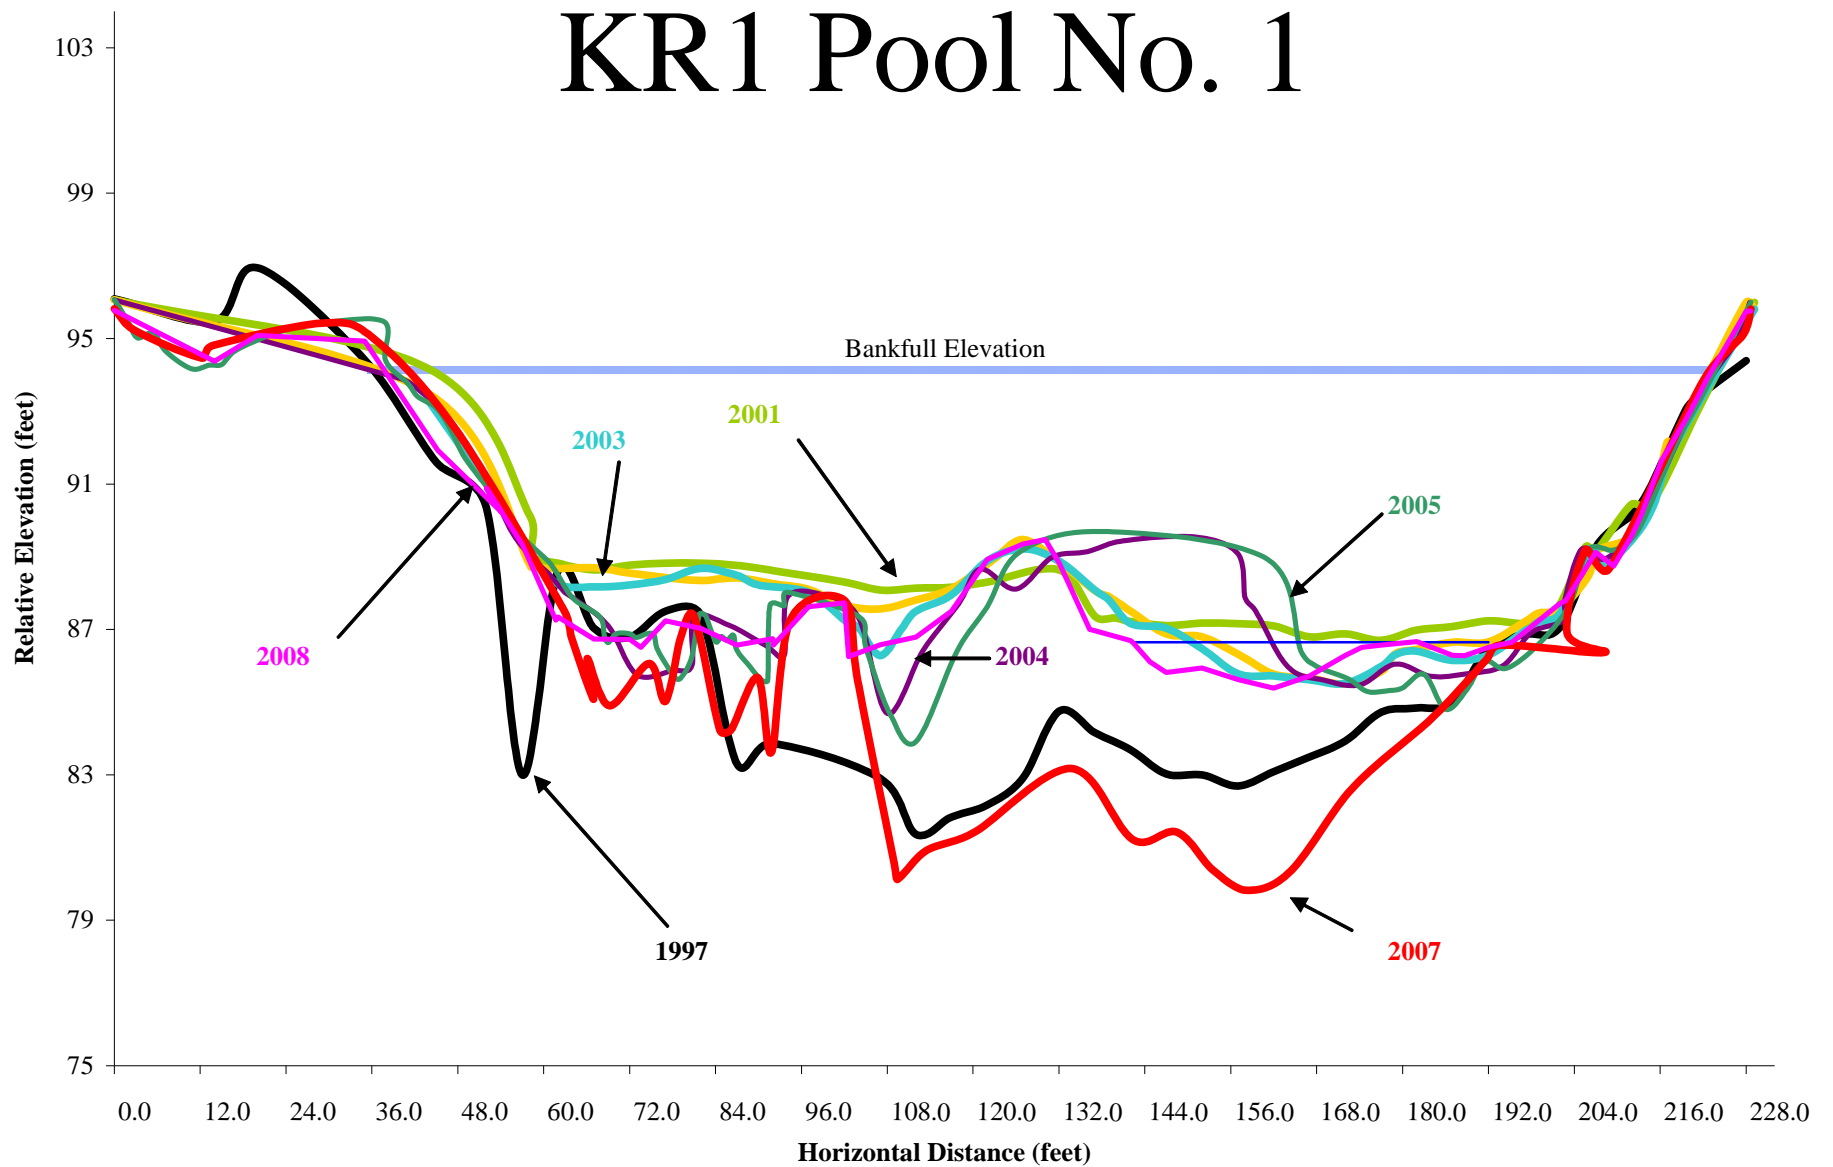
# KR1 Pool No. 1

| Bankfull Elevation | 1997 Channel Bed Elevation | 2001 Channel Bed Elevation | 2002 Channel Bed Elevation |
| 2003 Channel Bed Elevation | 2004 Channel Bed Elevation | 2005 Channel Bed Elevation | 2007 Channel Bed Elevation |
| 2008 Water Surface Elevation | 2008 Channel Bed Elevation | | |

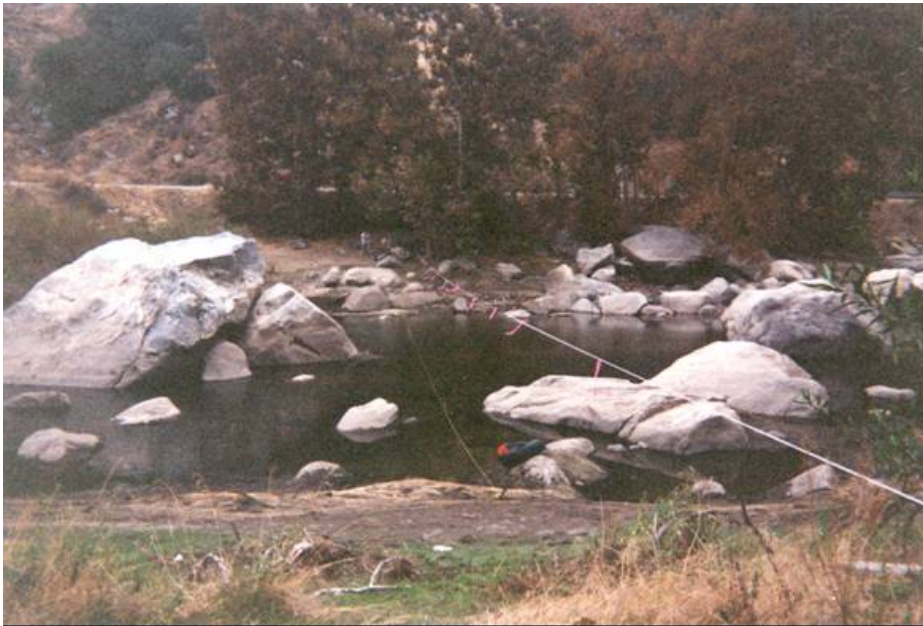
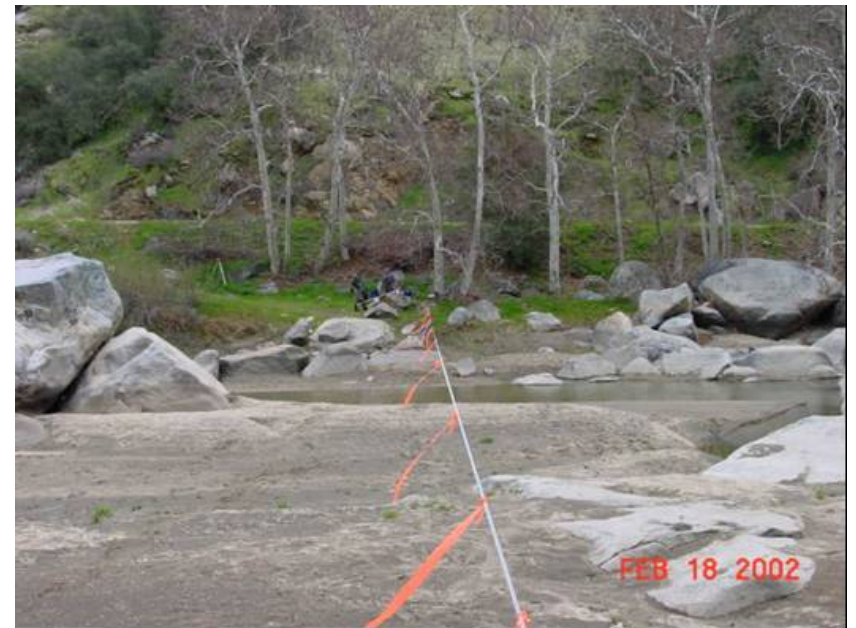
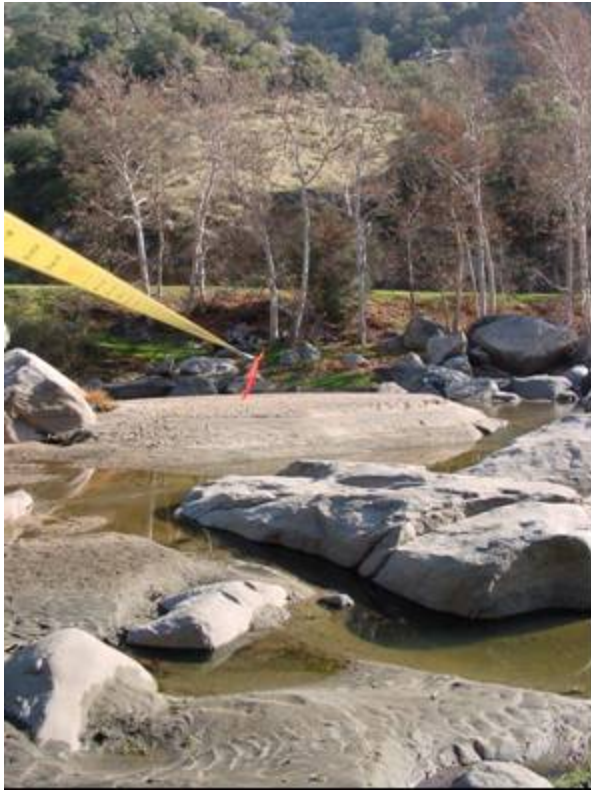
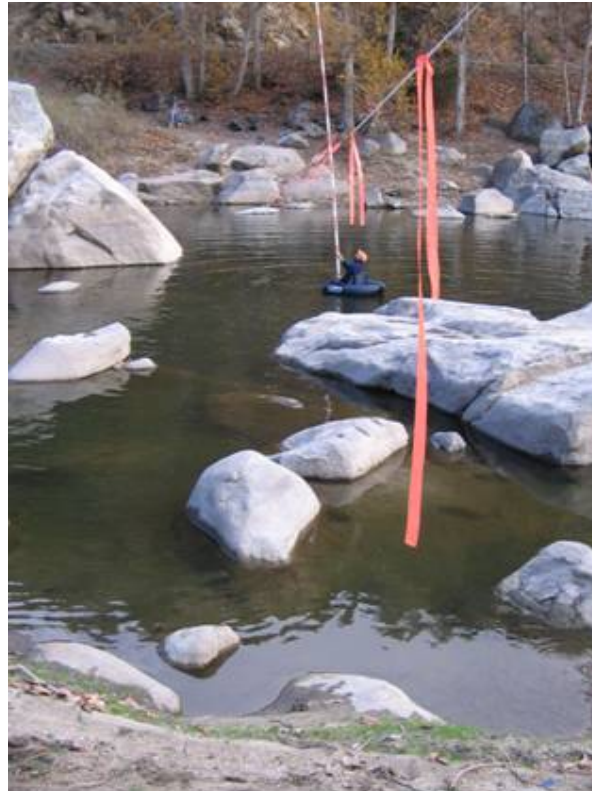
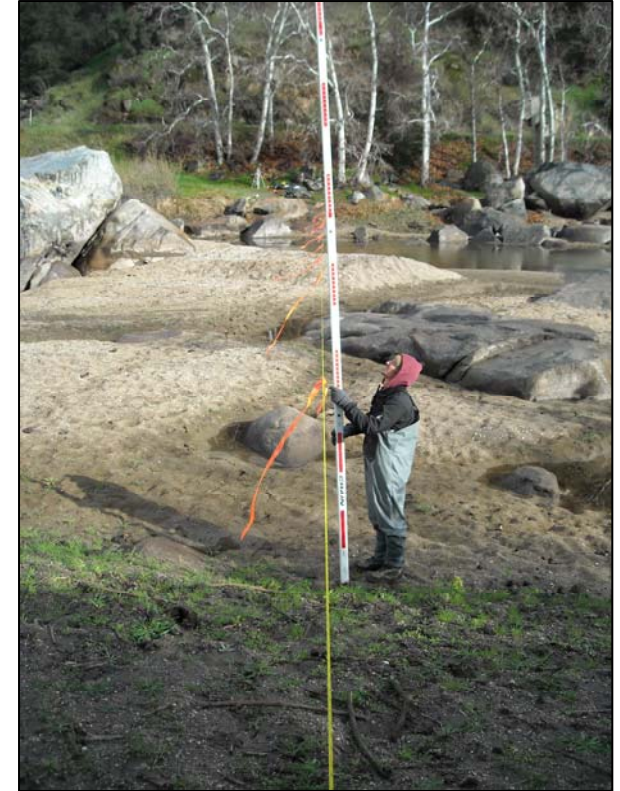
# Photo Comparison - KR1 Pool No. 1, Transect 1 View across channel from left bank

Photo Comparison - KR1 Pool No. 1,  
Transect 1  
View across channel from left bank

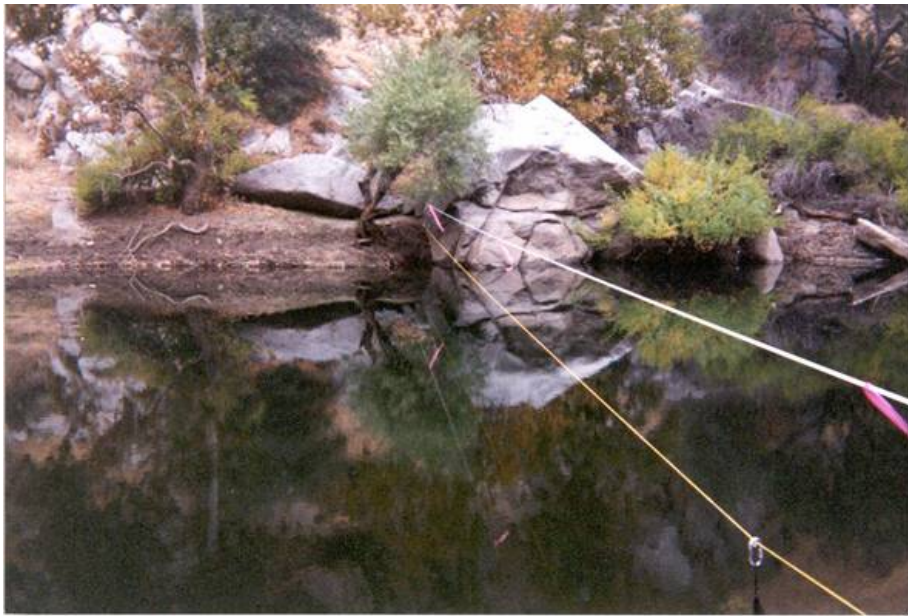
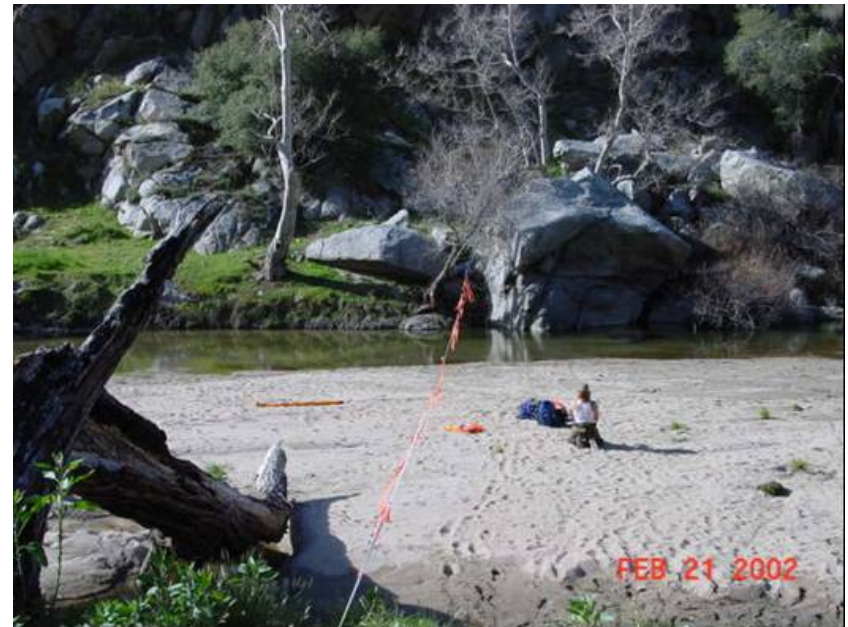
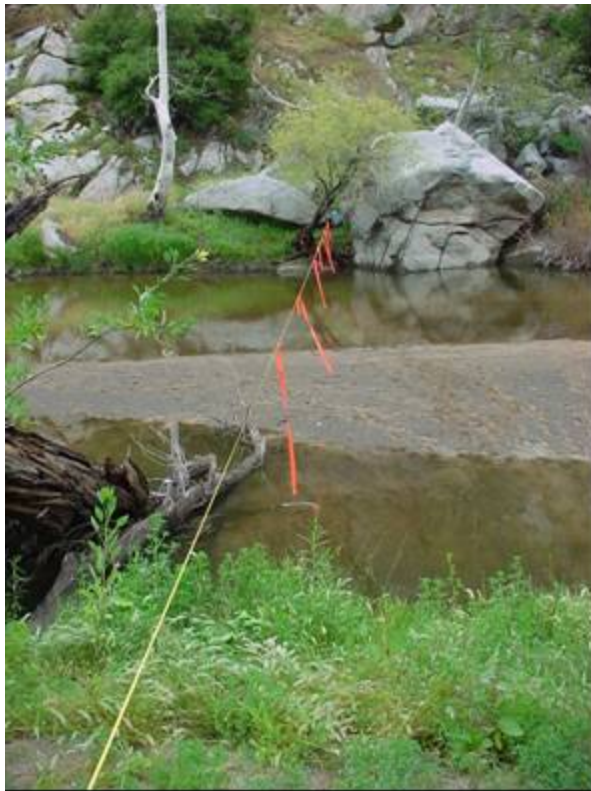
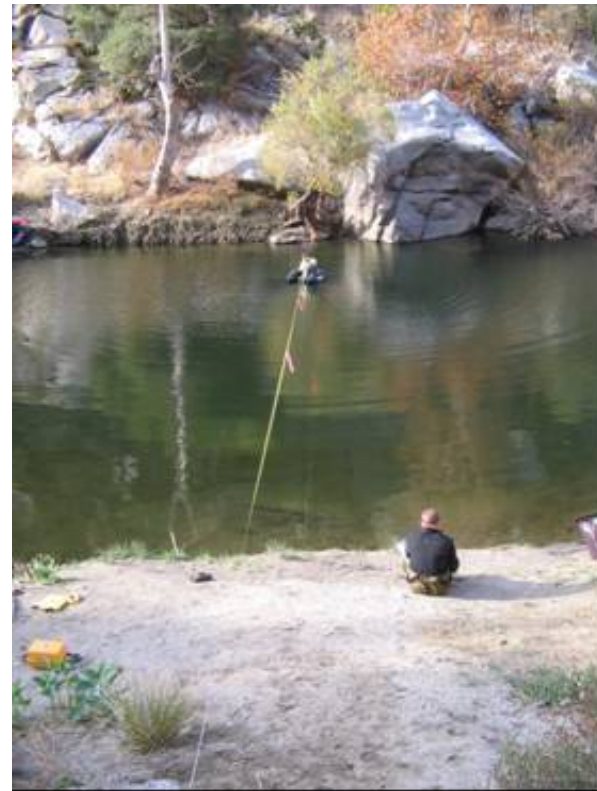
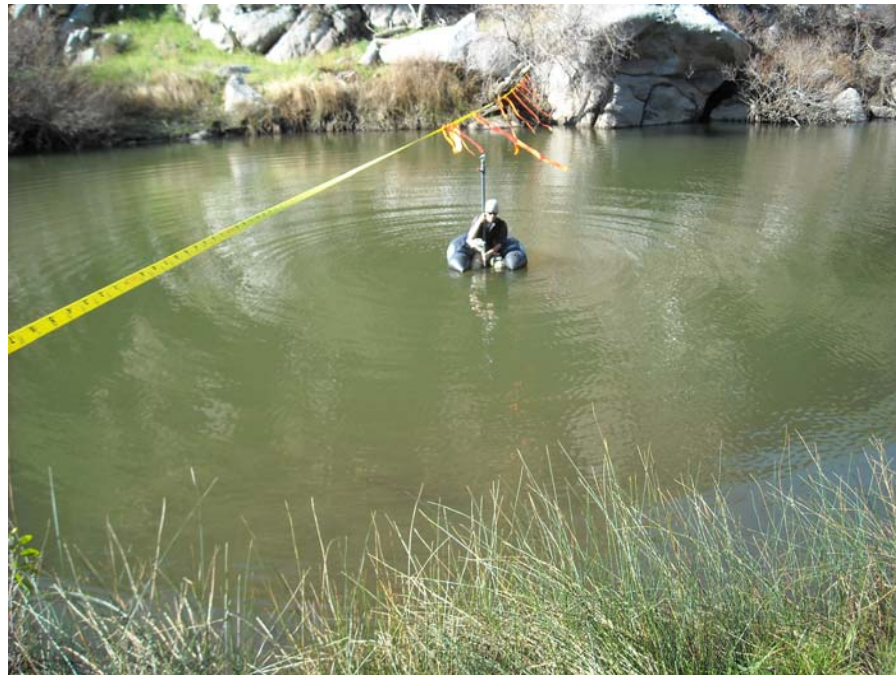
Photo Comparison - KR1 Pool No. 4,  
Transect 1  
View across channel from right bank

# Photo Comparison - KR1 Pool No. 4, Transect 1
